CLEARROOT MATERIALS LLC

# Example Investigations

Representative Materials Failure Analysis & Characterization Examples

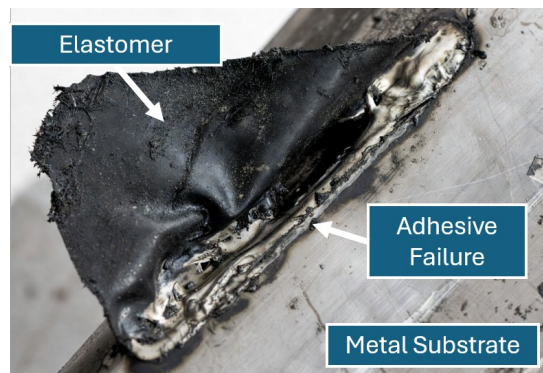
*Figure 1: Magnified image generated for educational reasons showing an elastomer debonding from a metal substrate.*

Assemblies that passed initial inspection began exhibiting bond-line delamination after 3–6 months in service (**Figure 1**). Internal investigations could not identify whether the root cause was adhesive selection, surface preparation, environmental exposure, or a manufacturing variation.

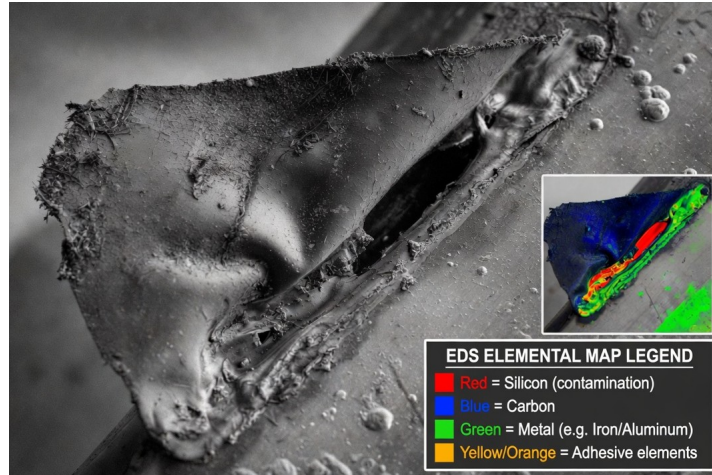
SEM/EDS elemental mapping (**Figure 2**) revealed localized silicon-rich regions (*red*) at the failed bond interface. These red regions were absent in control specimens. FTIR identified the silicone contaminant as polydimethylsiloxane (PDMS; **Figure 3**).

**Figure 2: Scanning Electron Microscopy image generated for educational purposes only. Here it demonstrates a failed part with an Elemental Map displayed on the bottom right. Red colored section indicates a silicon-containing material.**

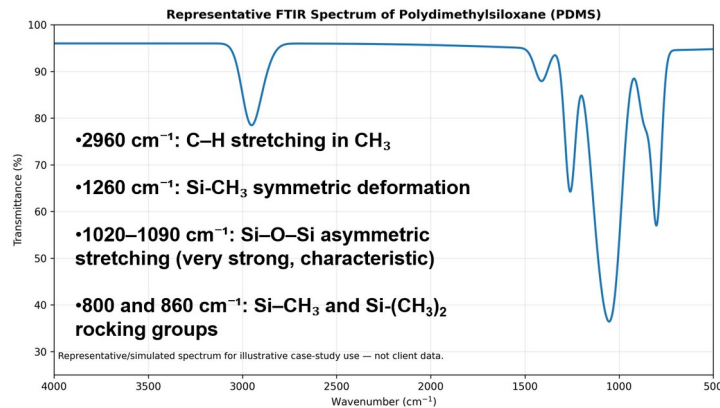
**Figure 3: Example FTIR spectrum of polydimethylsiloxane (PDMS). Image generated for illustrative purposes to demonstrate the type of analytical data commonly used during contamination investigations.**

**The primary failure mechanism was adhesion loss caused by silicone-based contamination on the metal substrate.** FTIR and elemental analysis confirmed polydimethylsiloxane (PDMS) on the bonding surface. This contamination was introduced during upstream molding operations from mold release agents. Silicone residue significantly reduced the metal surface energy, with failed surfaces exhibiting a 150% increase in WCA, indicating substantially reduced surface energy and poor adhesive ‘wettability’ (Figure 4). This prevented proper adhesive wetting, creating a weak boundary layer that propagated under thermal and humidity cycling.

- **Isolation:** Eliminated silicone-containing materials from all upstream handling and molding processes
- **Surface Quality Control:** Implemented a rapid, line-side water contact angle testing (< 40° prior to bonding)
- **Process Optimization:** Standardized robust surface cleaning and preparation procedures

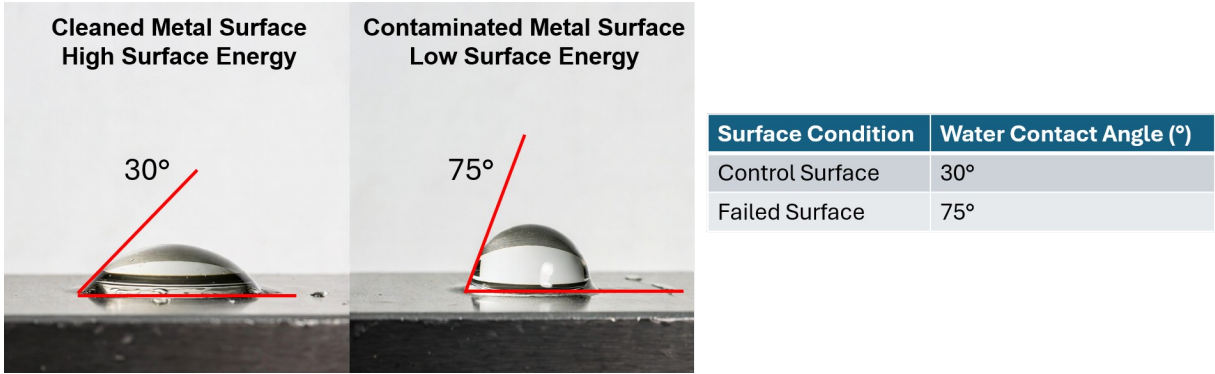
Figure 4: Water droplet placed on the control surface (left) vs. the failed surface (right). Image generated for illustrative purposes to better understand surface energy concepts.

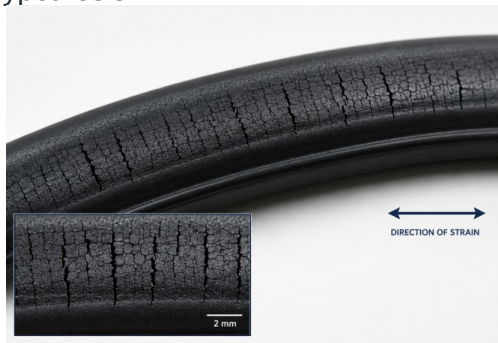
The elastomer seals passed initial qualification tests but developed surface cracks in 6–12 months of outdoor service (**Figure 1**). Internal investigations initially suggested mechanical overload or installation damage, yet the failure pattern did not align with either hypothesis.

**Failure Rate:** 12%  
**Service Life:** 6–12 months  
**Environment:** Outdoor Exposure  
**Component:** Elastomer Seal

*Figure 1: Failed industrial rubber part. Note cracking propagation relative to applied strain. Image generated for illustrative purposes.*

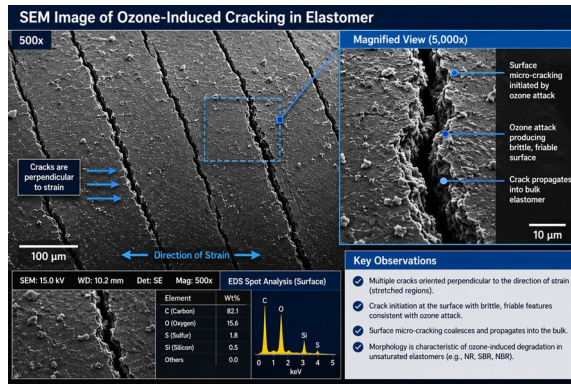
Fine surface cracks were observed perpendicular to the applied strain direction (**Figure 2**). The crack morphology is consistent with classical ozone attack. FTIR spectroscopy identified the failed material as natural rubber (cis-1,4-polyisoprene), an unsaturated elastomer known to exhibit poor resistance to long-term ozone exposure (**Figure 3**).

Figure 2: Representative SEM-style image generated for illustrative purposes to demonstrate the type of fracture surface features commonly evaluated during failure analysis investigations. This example is consistent with environmentally induced elastomer degradation.

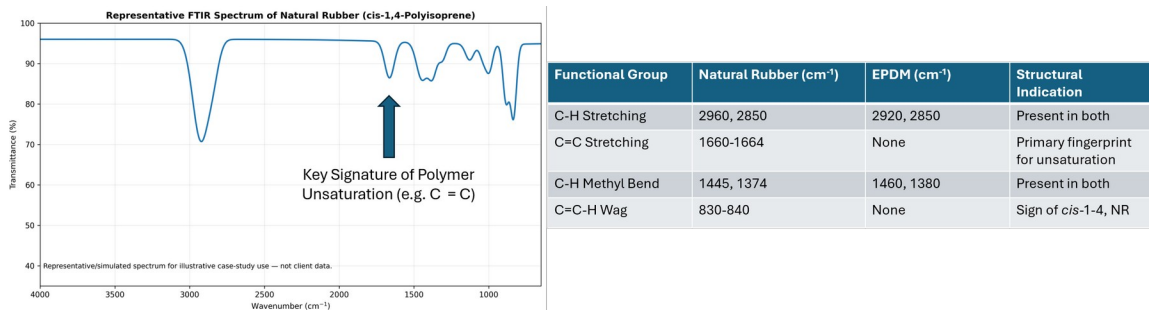
Figure 3. Representative cartoon FTIR spectrum of natural rubber (cis-1,4-polyisoprene). Spectral analysis identified the failed material as an unsaturated elastomer susceptible to ozone-induced degradation under long-term environmental exposure. Image generated for illustrative purposes to demonstrate analytical identification of elastomer materials.

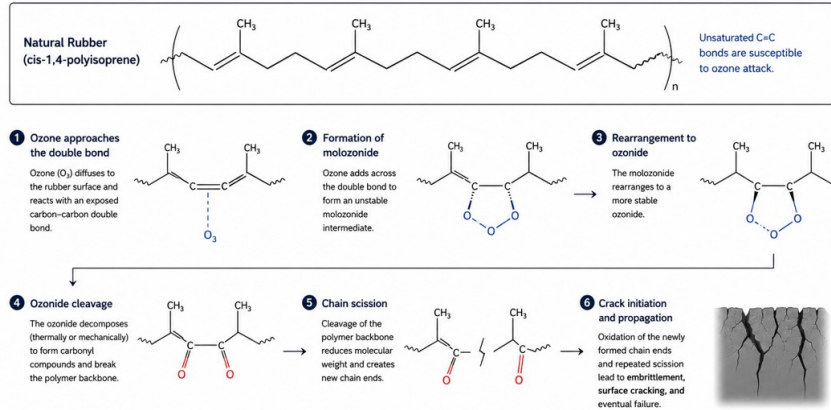
**The primary failure mechanism was ozone-induced degradation of an unsaturated elastomer that lacked adequate long-term ozone resistance.** Atmospheric ozone attacked the carbon-carbon double bonds in the polymer backbone, leading to chain scission and progressive surface cracking (Figure 4). Natural rubber was selected for an outdoor service environment where long-term ozone exposure was expected. The material lacked sufficient ozone resistance for the application.

*Figure 4: How ozone attacks natural rubber’s double bonds, causing chain scission, which ultimately makes the rubber part much harder, stiffer, and prone to cracking.*

- 1) Replaced existing natural rubber with ozone-resistant EPDM
- 2) Updated material specifications with ozone exposure requirements
- 3) Added accelerated ozone testing to qualification protocols
- 4) Implemented supplier material verification requirements (**Figure 5**)

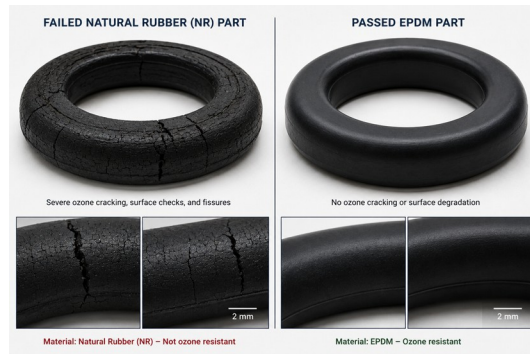
*Figure 5: Comparison of Failed Natural Rubber Part with EPDM Part.*

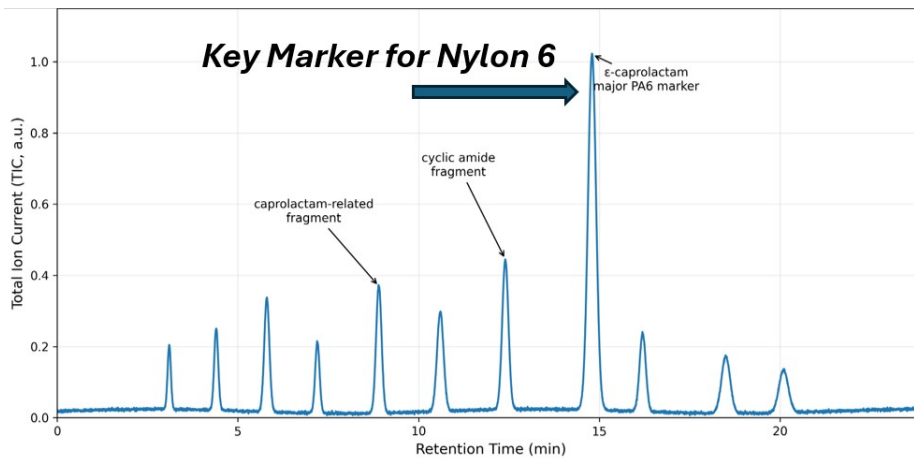
FTIR analysis identified the material as a polyamide (PA). Py-GC/MS subsequently confirmed the material to be Nylon 6 and NOT Nylon 11 or Nylon 12 through identification of characteristic  $\epsilon$ -caprolactam pyrolysis product (**Figure 2**). While Py-GC/MS confirmed all candidate materials contained a Nylon 6 chemistry, additional characterization was required to determine whether the formulations, including fillers, were truly equivalent.

**Figure 2: Example pyrogram illustrating characteristic Nylon 6 (PA6) decomposition products. Image generated for illustrative purposes to demonstrate the type of analytical data used during material identification investigations.**

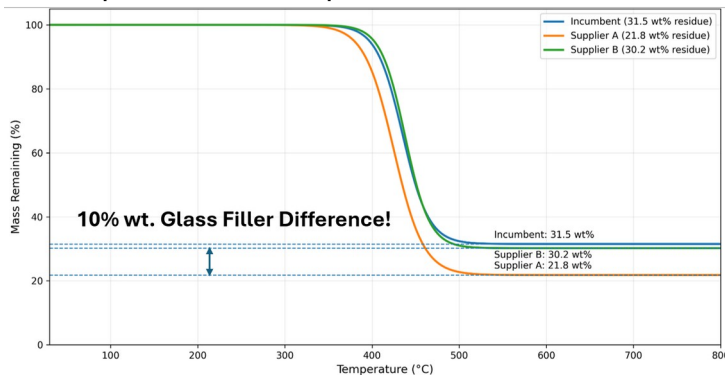
SEM/EDS and TGA characterization revealed 31.5% glass fiber reinforcement in the incumbent material compared to 30.2% (Supplier B) and 21.8% (Supplier A) (**Figures 3-4**). Comparative analysis demonstrated that one of the proposed replacement materials was not compositionally equivalent despite similar supplier descriptions.

*Figure 3: Example thermogravimetric analysis revealed that Supplier A contained substantially less inorganic reinforcement than the incumbent material despite both being marketed as 30% glass-filled Nylon 6. The results demonstrate the value of analytical characterization during supplier qualification and material substitution programs. Thermal image generated for illustrative purposes for educational reasons.*

- 1) Established analytical acceptance criteria for incoming materials
- 2) Qualified two alternative suppliers
- 3) Added FTIR verification for critical components
- 4) Created supplier equivalency requirements
- 5) Documented material composition for future procurement activities

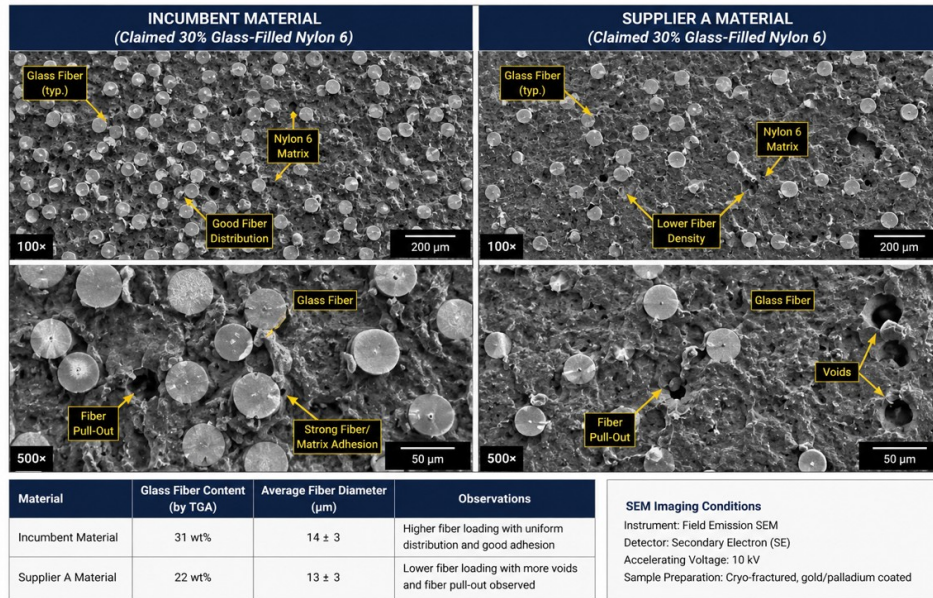
*Figure 4: Scanning electron microscopy (SEM) cartoon revealed differences in reinforcement density and fiber distribution between suppliers. The incumbent material exhibited a higher glass fiber loading and more uniform reinforcement network than Supplier A. Image generated for illustrative purposes only.*

**Supplier A's material was not compositionally equivalent to the incumbent material despite being marketed as 30% glass-filled Nylon 6.** Analytical characterization revealed significantly lower reinforcement content and formulation differences that would likely have reduced mechanical performance and long-term durability.
