CLEARROOT MATERIALS LLC

Representative Materials Failure
Analysis & Characterization Examples

EXAMPLE INVESTIGATION CRM-CS-001

Adhesive Bond Failure Investigation: Silicone Contamination in Elastomer-to-Metal Bonds

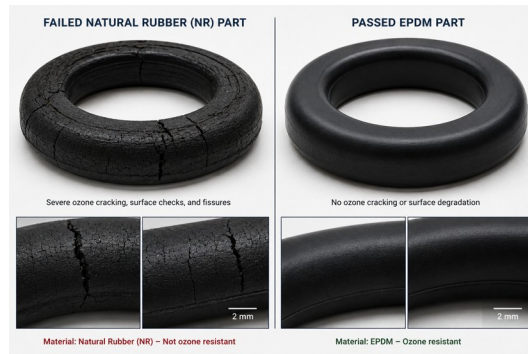
Figure 5: Comparison of Failed Natural Rubber Part with EPDM Part.

- 1) Replaced existing natural rubber with ozone-resistant EPDM
- 2) Updated material specifications with ozone exposure requirements
- 3) Added accelerated ozone testing to qualification protocols
- 4) Implemented supplier material verification requirements (Figure 5)
